# Energy Efficiency Improvement Potential in Historical Brick Building

Andra Blumberga<sup>1</sup>, Gatis Zogla<sup>2</sup>, Kristaps Zvaigznitis<sup>3</sup>, Dagnija Blumberga<sup>4</sup>, Marija Burinskienė<sup>5</sup>, <sup>1-4</sup> Riga Technical University, <sup>5</sup>Vilnius Gedeminas Technical University

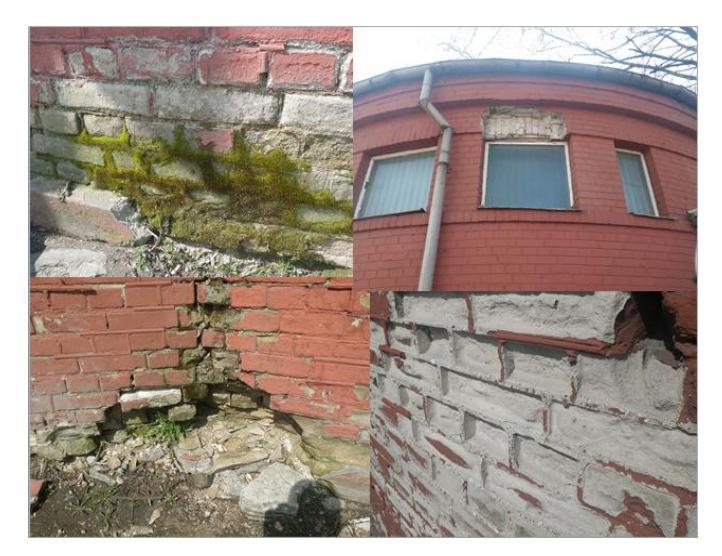
Construction damage above the window was observed, indicating potential moisture penetration from the roof. The damage reveals deeper, unpainted bricks which, opposed to the bricks on the surface, have not formed a surface layer over time, so they are more rapidly exposed to moisture damage. The wrong design contributed these defects, because there are no lintels. All the bricks are immured in parallel vertically and without complying with the required angle. Damage is observed at the bottom as well, where the gutter is not at the required angle and, as a result, rain water leaks into the walls. At the top left moss growth is observed, leading to intensifying of brick deterioration.

Fig.2. Damaged building envelope elements

The final parts of building gutters are missing, and due to this, water is not drained 20 - 40 cm above the ground as recommended, but about 160 to 220 cm in height. One of the building windows has been replaced with plywood, which is not suitably fixed. At the bottom of Figure 2, damage to the construction of the wall is visible, where the whole bricks are missing and the stitches crumbling away. Damages can be observed up to a height of 2 m on the annex joint.

The top and final leg of gutter is missing, which results in moisture draining into the wall. At the bottom of the picture moisture damage to the building's foundations can be observed and on the right of the picture -- part of the joint has fallen out.

The estimated existing energy consumption for space heating of the building is 37.93 MWh per year, or 672 kWh/m<sup>2</sup> per year. Measured heat transfer coefficient for bricks is different from the calculated values, which is based on the element structure and obtained using ISO 6946-1. The calculated heat transfer coefficient is lower  $(1.32 \text{ W/m}^2\text{K})$  than measured (1.48 W/m<sup>2</sup>K). Moisture and freeze - thaw cycles have done considerable damage to external wall structures of the Maskavas iela 8 building. The main cause of damage is poor technical condition of roof gutters. While the main reasons for masonry cracking are three: intense traffic and transport, poor foundations and groundwater fluctuations. The brick sample, which was taken from the building at Maskavas 8 showed minimum concentrations of nitrate and sulfate salt content. The building needs strengthening of wall constructions in places where cracks, loose joints and shifted bricks have developed. It is necessary to strengthen the window boxes, check the moisture barrier and prevent flaking of the joints.

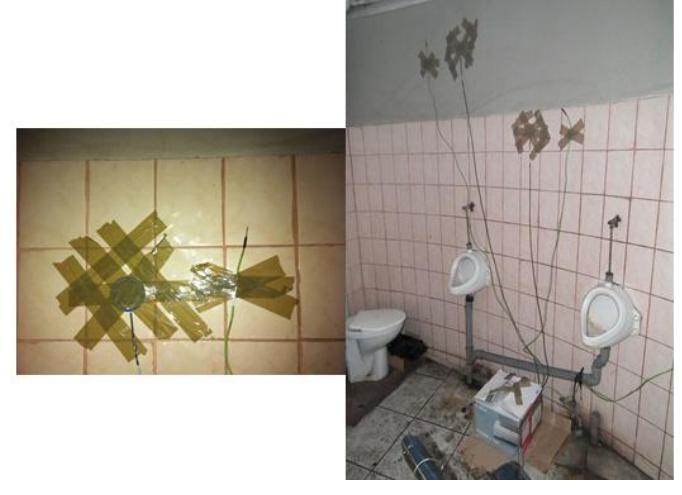
Measurements have 10 minute time step. Figure 4 shows more than 11 days of measurements. During the measurements the building was heated with two 2 kW electrical heaters that were put to operate all the time with a constant heat output (4 kW).

Fig.3. Heat flux measurements at Maskavas 8

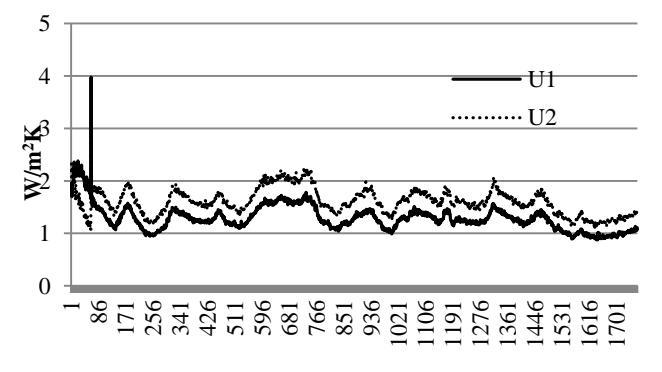
Fig. 4. Instantaneous heat transfer coefficients of the walls of Maskavas 8

As can be seen from the figure, the measured heat fluxes were not the same but different. This means that heat transfer through the outer walls is the same in the entire façade. The changes in heat transfer throughout the wall lead to believe that different parts of the walls have suffered different damage from water, ice thawing, air pollution. This also is supported by visual inspection of the building from outside what was examined above in this paper.

Measured heat transfer coefficient was in the range from 1.3 to 1.6 W/m<sup>2</sup>K. The average heat transfer coefficient was calculated to be 1.48 W/m<sup>2</sup>K. Measured heat transfer coefficient of outer walls is higher than the calculated heat transfer coefficient for 51 cm thick silicate brick wall.

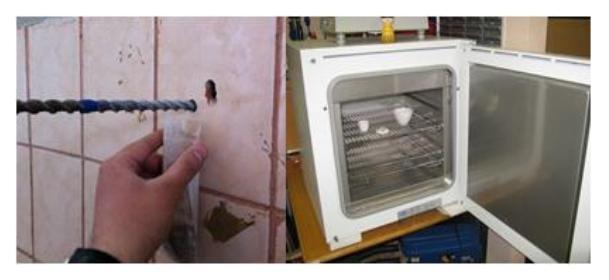
Unfortunately these measurements just showed that this method cannot be used for determining moisture content in bricks due to the heating up of the drill during drilling. The temperature of the drill during drilling exceeds 150 °C. This is enough to remove part of the moisture of the brick even before drying the brick dust in the oven. There is a need for creating new techniques for determining and quantifying the moisture content of bricks in building walls.

Fig. 6. Drilling and collecting of brick dust and the drying oven used for drying brick dust

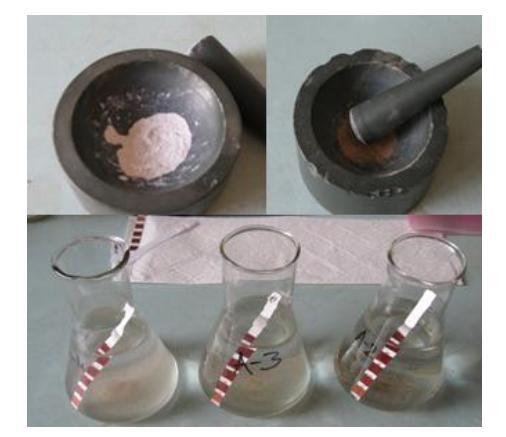
Fig.7. Qualitative water-soluble salt test method

It was determined that the sample contains 2,5 mg/l  $NO_3^-$  and minimal amount of  $SO_4^{2^-}$  that can be caused by acid rains, sulfates may also form in brick burning process.
