# Energy Efficiency Improvement Potential in Historical Brick Building

Andra Blumberga<sup>1</sup>, Gatis Zogla<sup>2</sup>, Kristaps Zvaigznitis<sup>3</sup>, Dagnija Blumberga<sup>4</sup>, Marija Burinskienė<sup>5</sup>, <sup>1-4</sup> Riga Technical University, <sup>5</sup>Vilnius Gedeminas Technical University

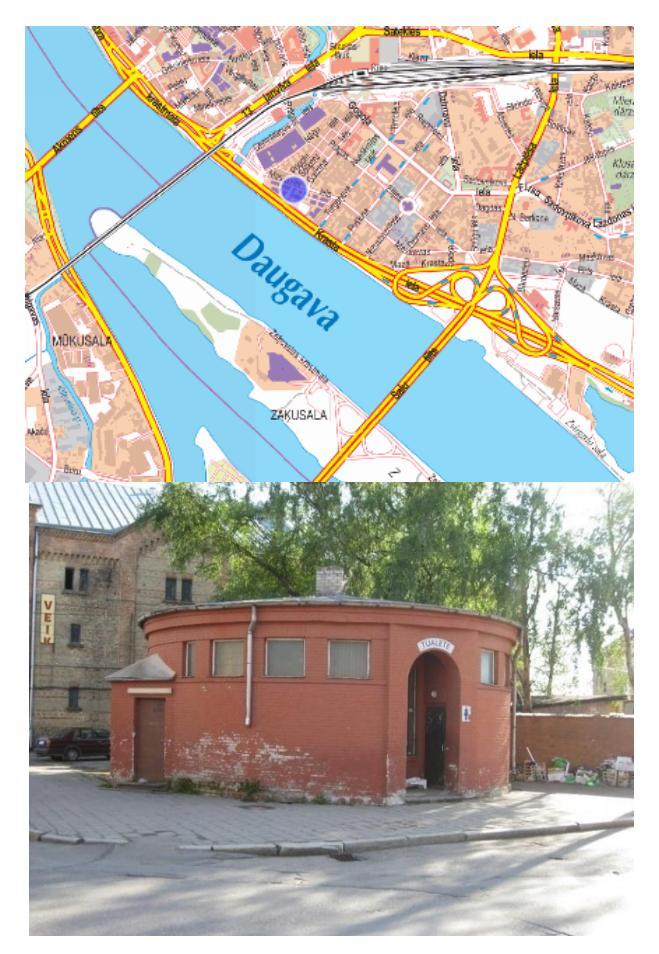
Fig. 1. Building Maskavas iela 8, Riga, location and facade

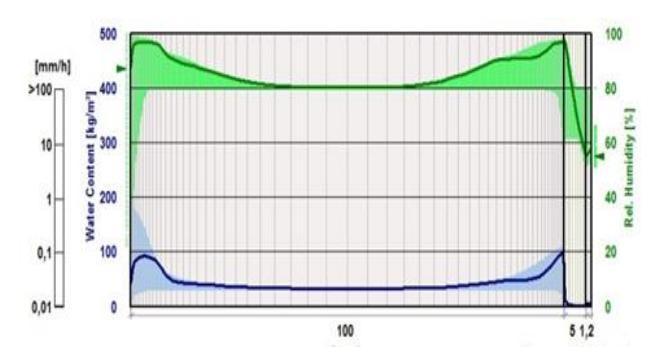
Measurements showed that the moisture in the wall has penetrated in the shallow depths (up to 5 cm). The deeper layers of the wall are dry. This correlates with our research done by modeling moisture content of brick walls for similar building in Riga at Kronvalda blvd 1 (see Fig.5).

Fig. 5. Moisture content modeling for brick wall that is insulated from inside with rock wool

Moisture content modeling of a similar building was done with software WUFI, which is used worldwide for modeling moisture penetration in building envelope. In Figure 5 it can be seen that relative humidity and water content of the wall throughout the year varies a lot on both the inner and other surfaces of the wall, but in the middle part -- humidity and moisture content practically does not change and is constant. Moisture can penetrate walls only if walls have cracks, brick deterioration or other damage that can be seen with the naked eye.
